Manhole Inspection Summary

Manhole # S27A__036MH

Cannot Access - Buried - Manhole Existing Confirmed by CCTV- The Inspection Is For a Wrong Manhole S27A__076MH

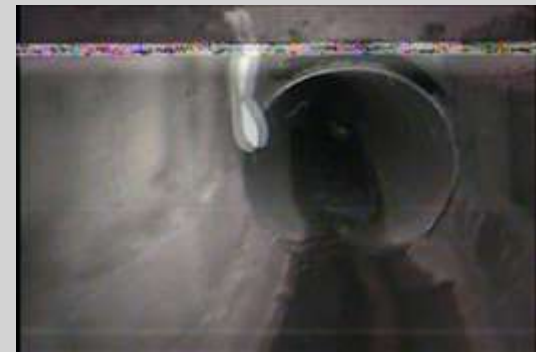
8 in. Circular Gravity Sewer
Pipe Out @ 12 O'Clock

Pipe Height: **8.4** (in.) Rod and Bar (Angled)
Pipe Material: **PVC** ☐ Pipe Lined
Invert Depth: **11.85** (ft.) Flow Characteristics: **Slow**
Deposits: ☒ None ☐ Mud ☐ Sludge ☐ Debris ☐ Grease
Silt Depth: (in.) Deposits Extent:
Infiltration: **None** Pipe Seal Cond: **Sound**

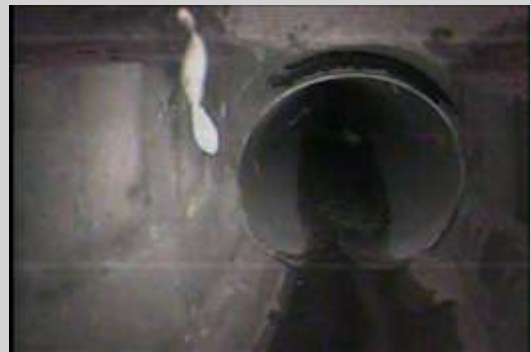
12 O'Clock Outflow
Pipe Out @ 12 O'Clock

Drop: **None**

Connects To: **Manhole**

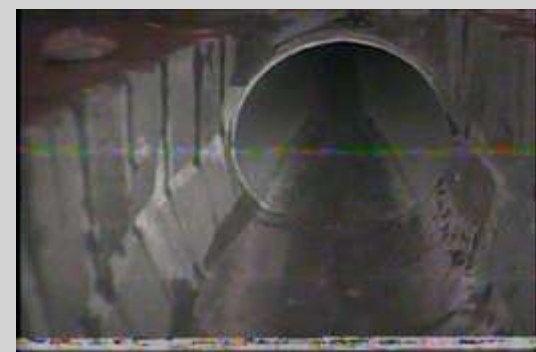
8 in. Circular Gravity Sewer
Pipe In @ 9 O'Clock

Pipe Height: **8.4** (in.) Rod and Bar (Angled)
Pipe Material: **PVC** ☐ Pipe Lined
Invert Depth: **11.78** (ft.) Flow Characteristics: **Slow**
Deposits: ☒ None ☐ Mud ☐ Sludge ☐ Debris ☐ Grease
Silt Depth: (in.) Deposits Extent:
Infiltration: **None** Pipe Seal Cond: **Sound**

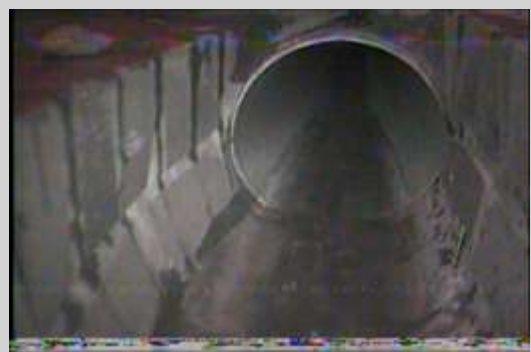
9 O'Clock Inflow
Pipe In @ 9 O'Clock

Drop: **None**

Connects To: **Manhole**
